Close Out Documents

AP-33 – 4637 Claude Ct.

Structural Demolition

Structure Survey Assessment Report AP-33

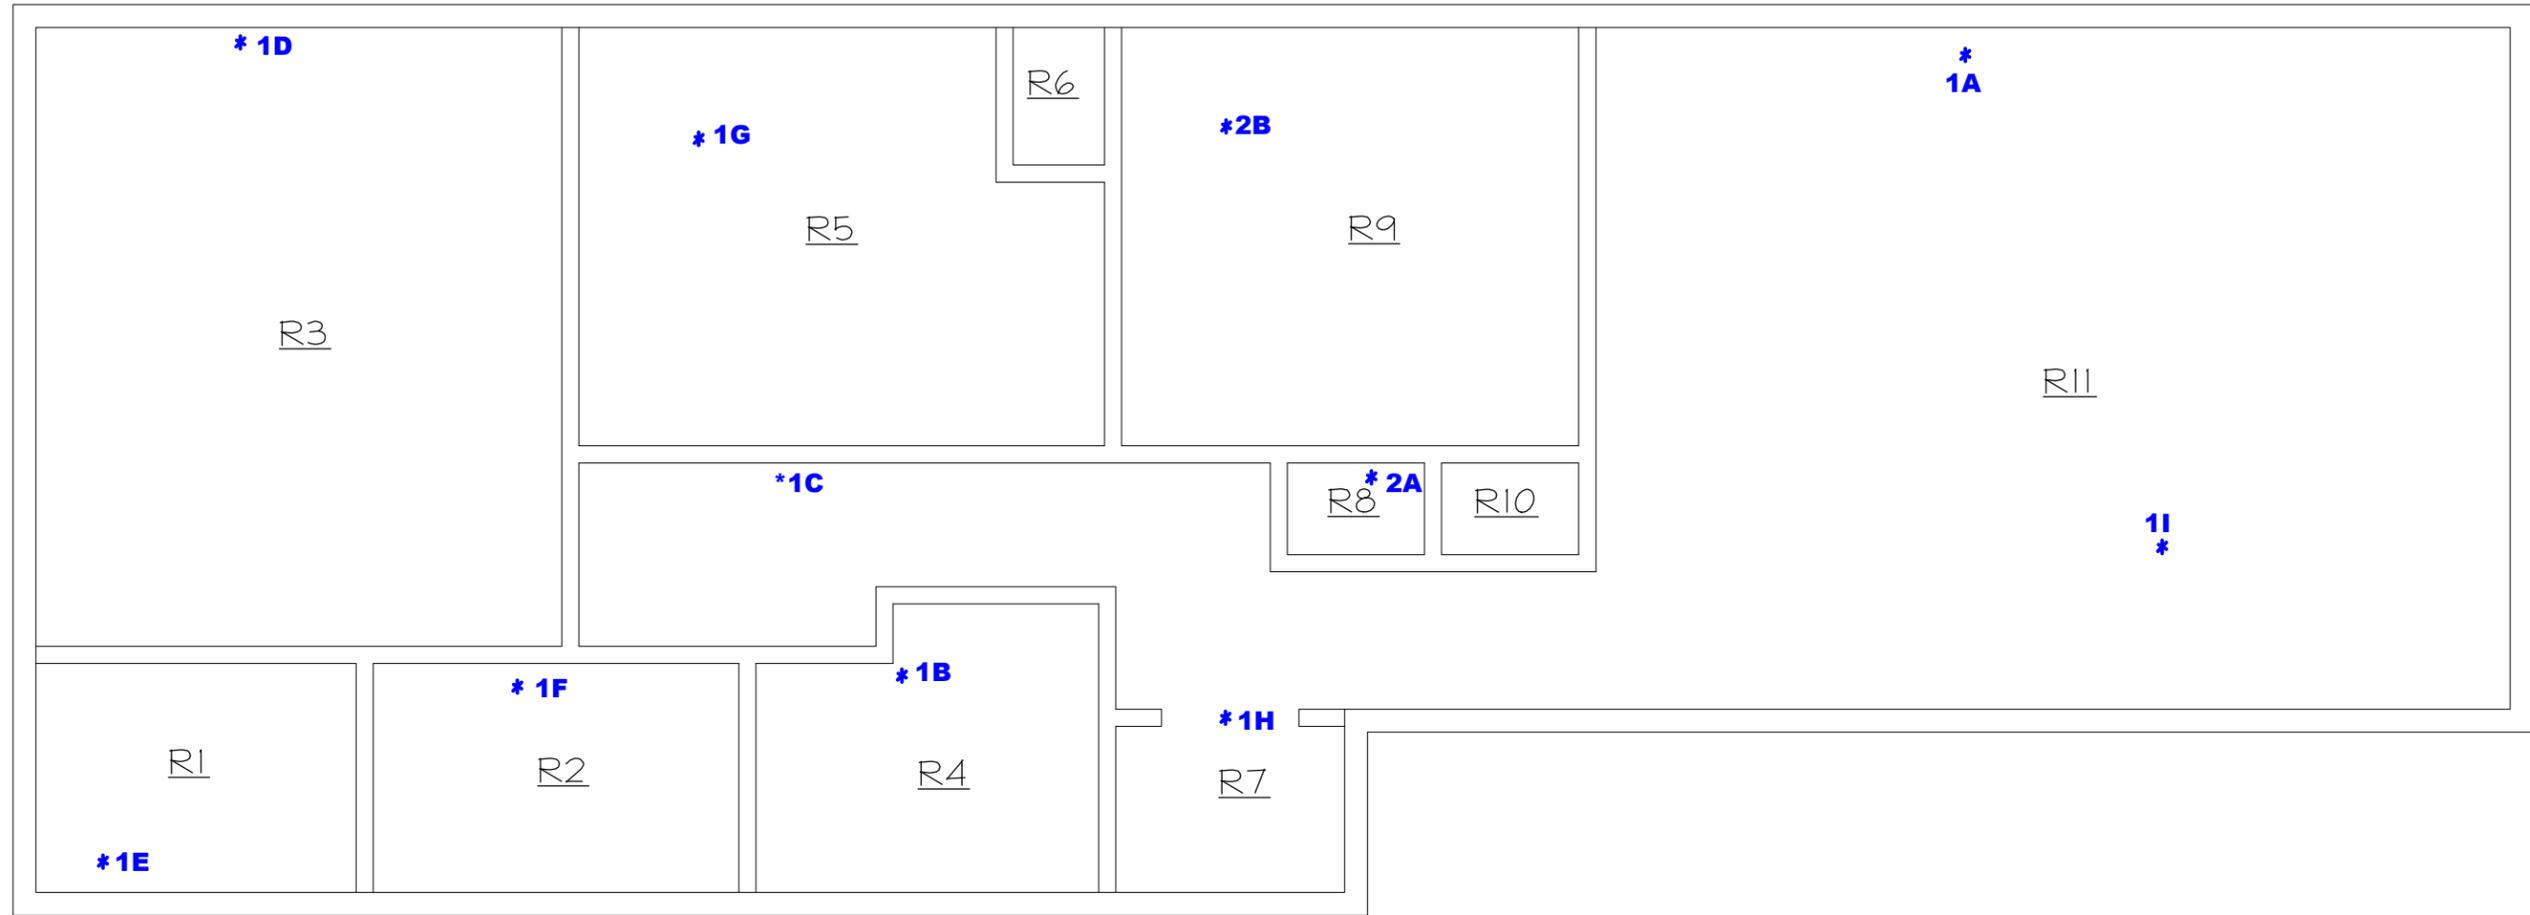
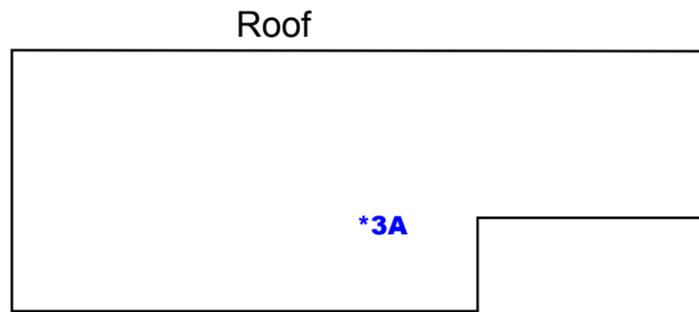
FIGURE 2 - Asbestos Bulk Sample Locations
 CENTRAL 70 - Structure Survey Assessment Map
 AP-33
 4637 Claude Ct., Denver, CO
 April 26, 2018
 APEC #: 18-3066

A total of 16 bulk samples were collected from 4 suspect homogenous materials throughout the structure, and the results of the PLM analysis are presented in Table 3-1. **No materials analyzed positive for ACM (i.e. present greater than 1%).**

- R1 = Room Numbers
- *4B = Asbestos Samples (Detect)
- *4B = Asbestos Samples (Non-Detect)

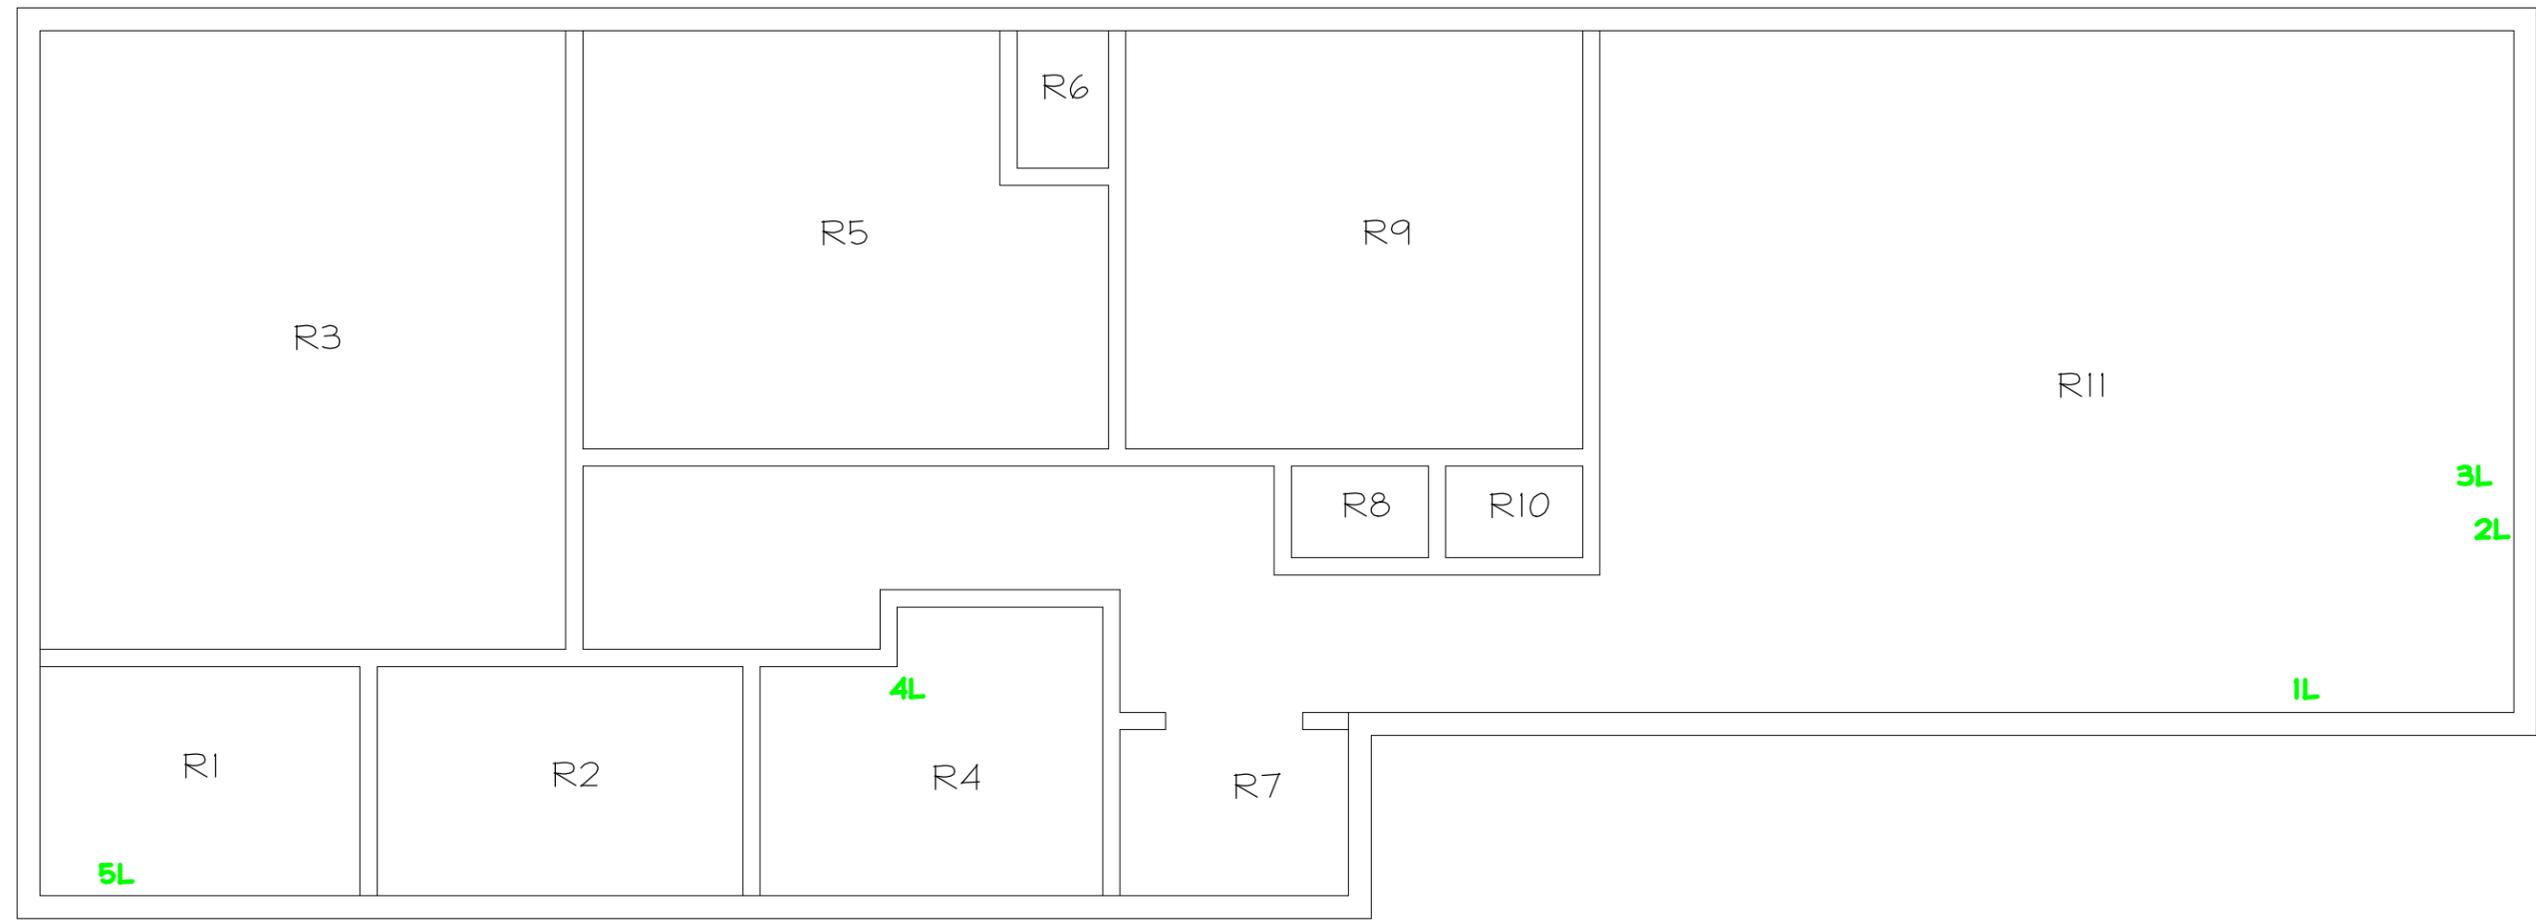
FIGURE 3 - Lead-Based Paint Sample Locations
 CENTRAL 70 - Structure Survey Assessment Map
 AP-33
 4637 Claude Ce., Denver, CO
 April 26, 2018
 APEC #: 18-3066

A total of 5 homogeneous paint color variations were analyzed for the presence of LBPs and LCPs (Table 3-2; Figure 3). Under EPA 40 CFR Part 745, LBP is defined as any paint or surface coating that contains lead equal to or exceeding 0.5% (by weight), while LCP is defined as any paint or surface coating containing lead greater than or equal to 0.06% up to 0.5% (by weight). For all other facilities, caution should be taken during demolition to minimize cutting, abrading, or otherwise causing an air disturbance to this material and work must be completed in accordance with the OSHA Lead in Construction Standard (29 CFR 1926.62).

All 5 samples analyzed less than the regulated LCP and LBP thresholds, and are considered non-lead containing paint (NLC). No lead abatement is required prior to demolition. TCLP results confirmed that the waste stream is not hazardous with respect to lead content.

- R1 = Room Numbers
- 4 = Lead Base Paint (Detect)
- 4 = Lead Containing Paint (Detect)
- 4 = Lead Base Paint (Non-Detect)

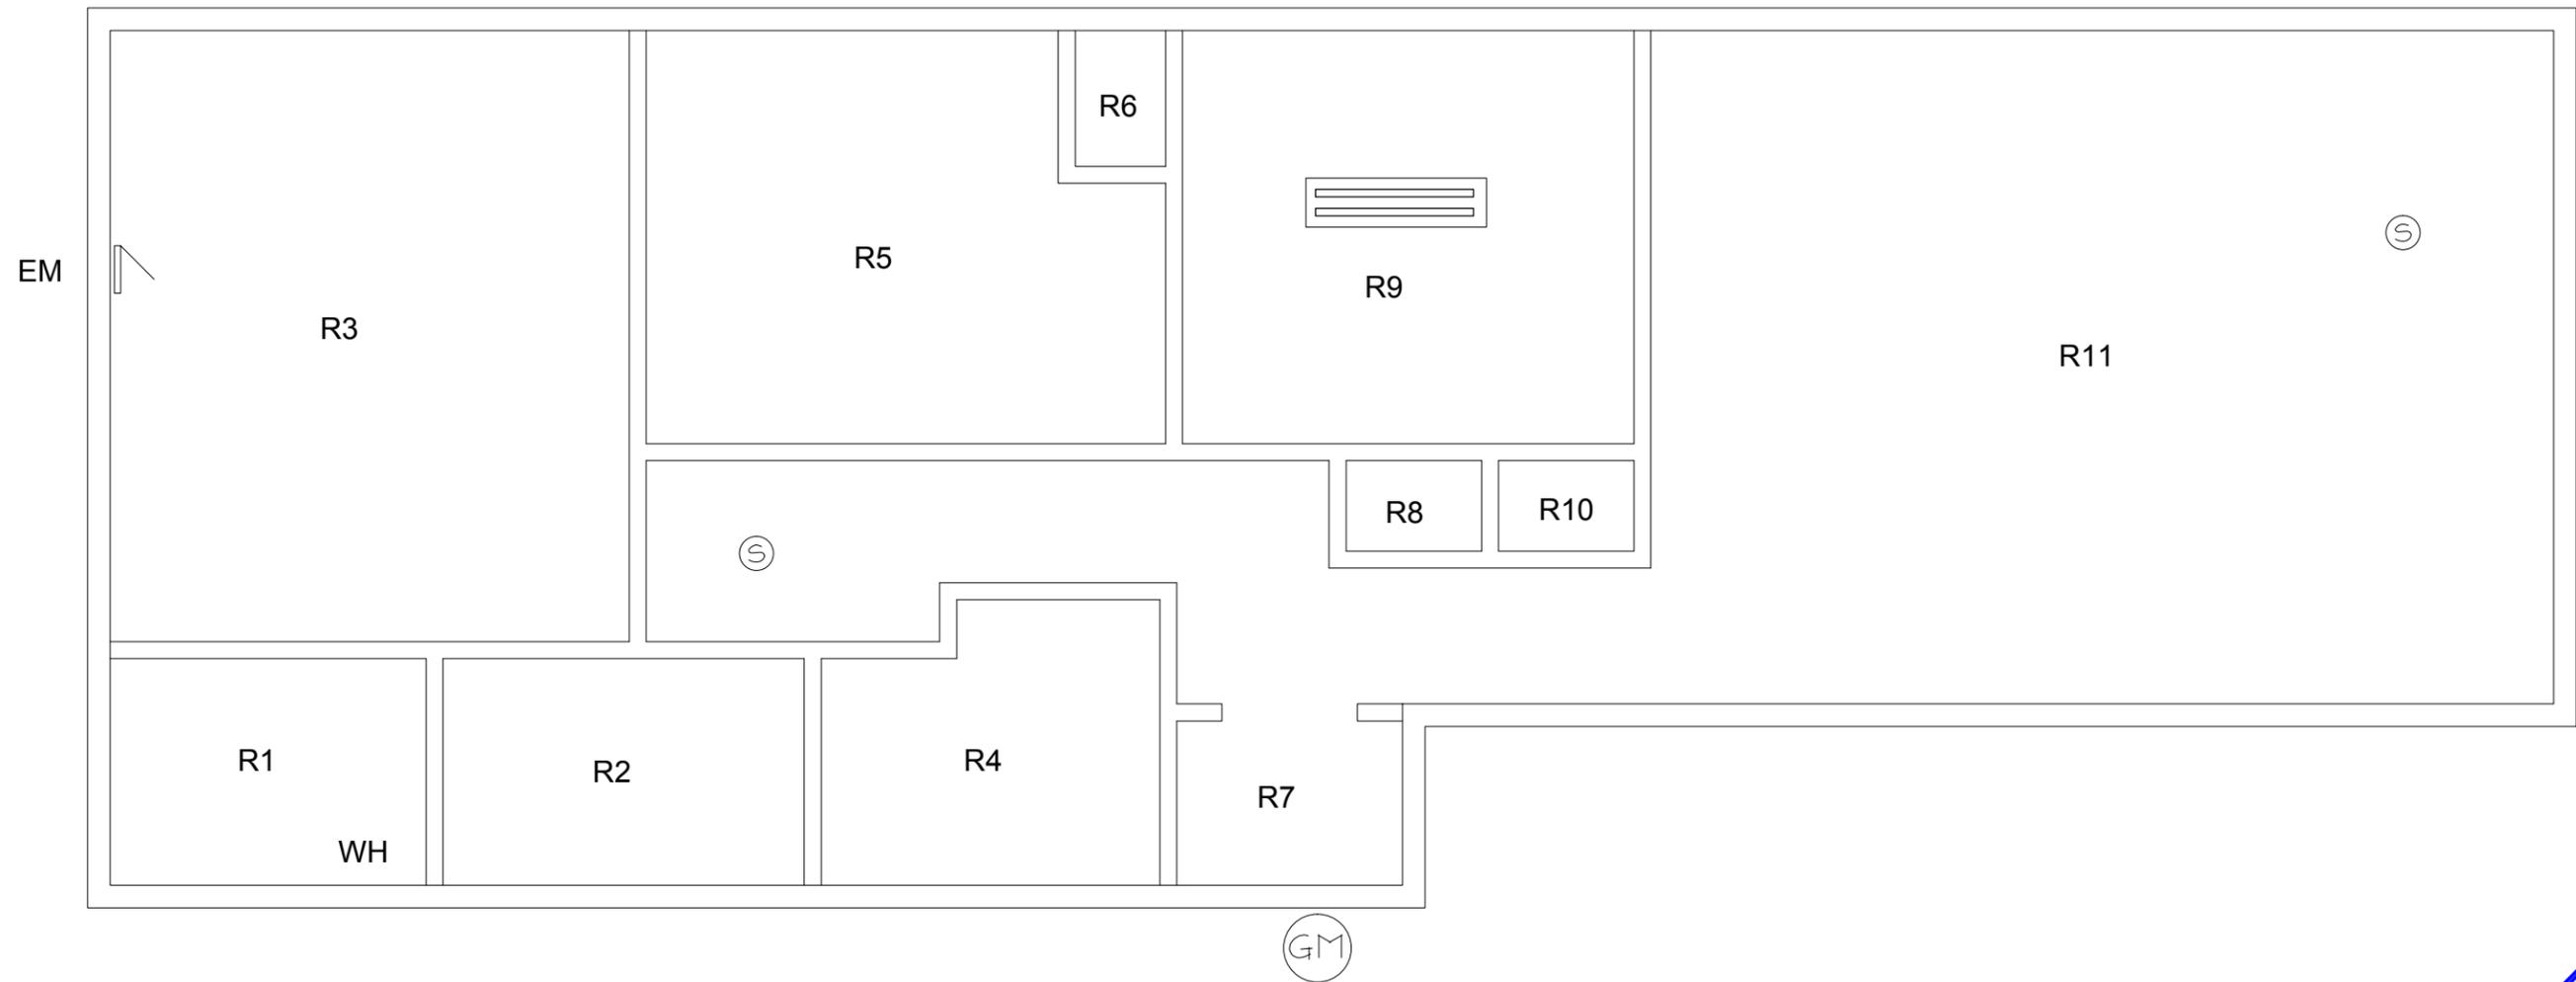
Several suspect RBMs were visually identified throughout the structure. RBMs that are a cause of concern, when discovered, are discussed below. A complete list of the RBMs is presented in Table 3-3, and selected locations of the RBMs are depicted in Figure 4.

R1 = Room Numbers
 EM = Electrical Meter
 GM = Gas Meter

Materials found during the regulated materials inventory within the building may require special handling or disposal prior to demolition activities. If abatement is needed, APEC recommends that the asbestos contractor or general contractor selected by the client properly dispose of these regulated materials, per applicable regulations.
